# **INDOOR AIR QUALITY**

## **SPECIFYING MATERIALS AND FINISHES FOR HEALTHY HOMES**

# **Boston's First Affordable Health House**

# **Maverick Gardens Hope VI Mid-Rise Development**

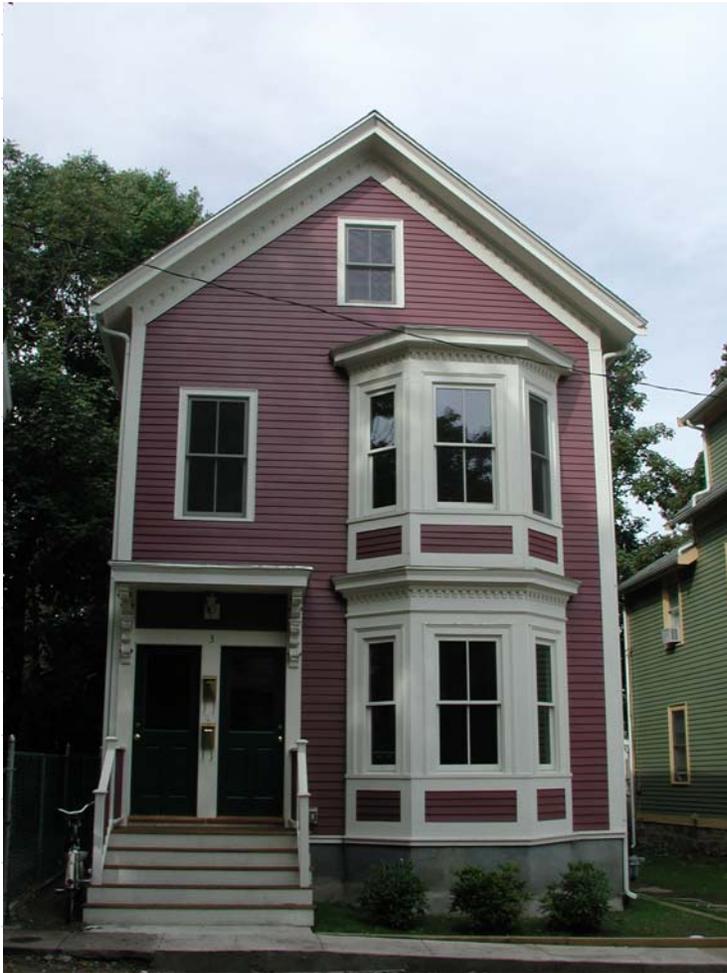
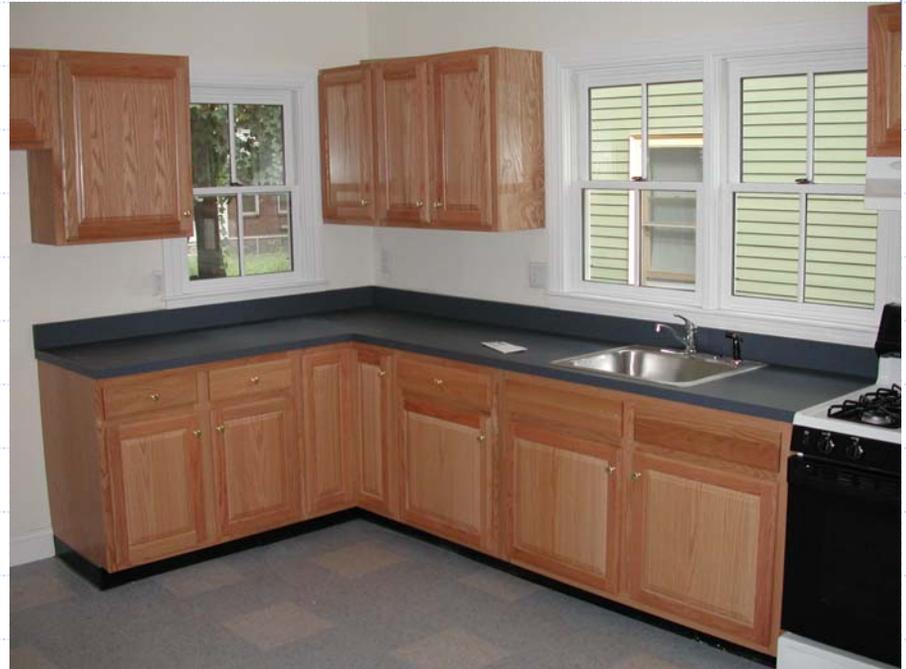
# The House – After

# Priority #1: Control Moisture

- ◆ **Roof** - New asphalt, gutters & downspouts
- ◆ **Windows** - Pan flashing
- ◆ **Basement/Foundation** - French drain, insulate walls
- ◆ **Insulation/Vapor and Air Control** - Install Icynene spray insulation

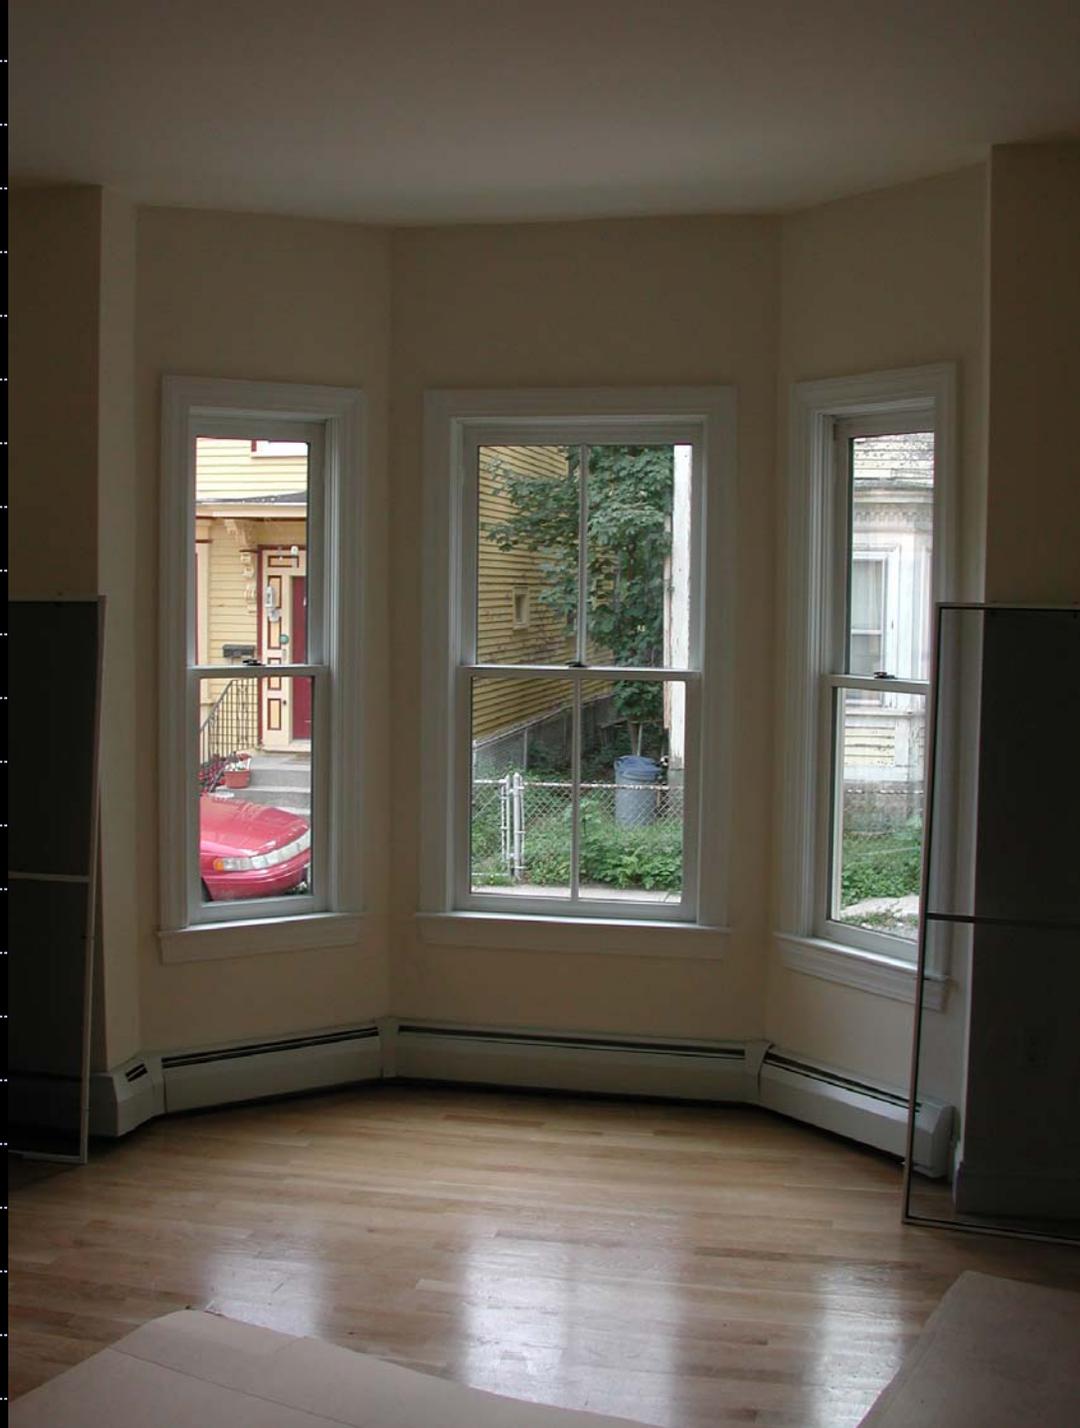
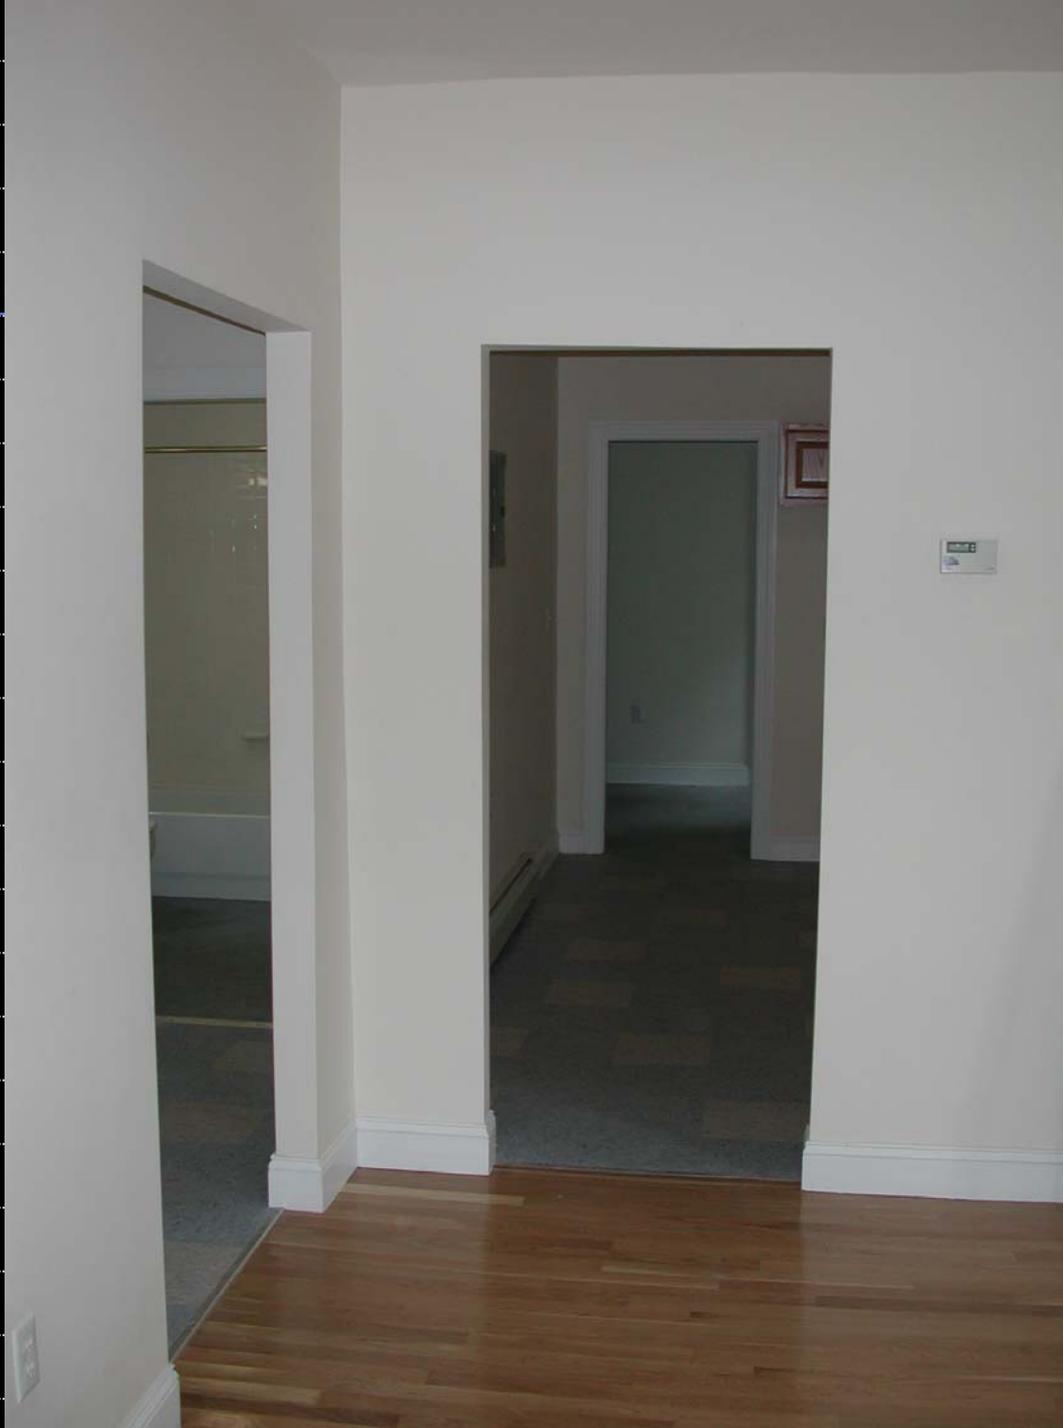
# Priority #2: Control Dust, Bugs, and Rodents

- ◆ No Wall to Wall carpeting. Mix of wood, vinyl composition tile, and natural linoleum
- ◆ Increase storage space
- ◆ Seal holes and add mesh
- ◆ Provide HEPA filter vacuum cleaner

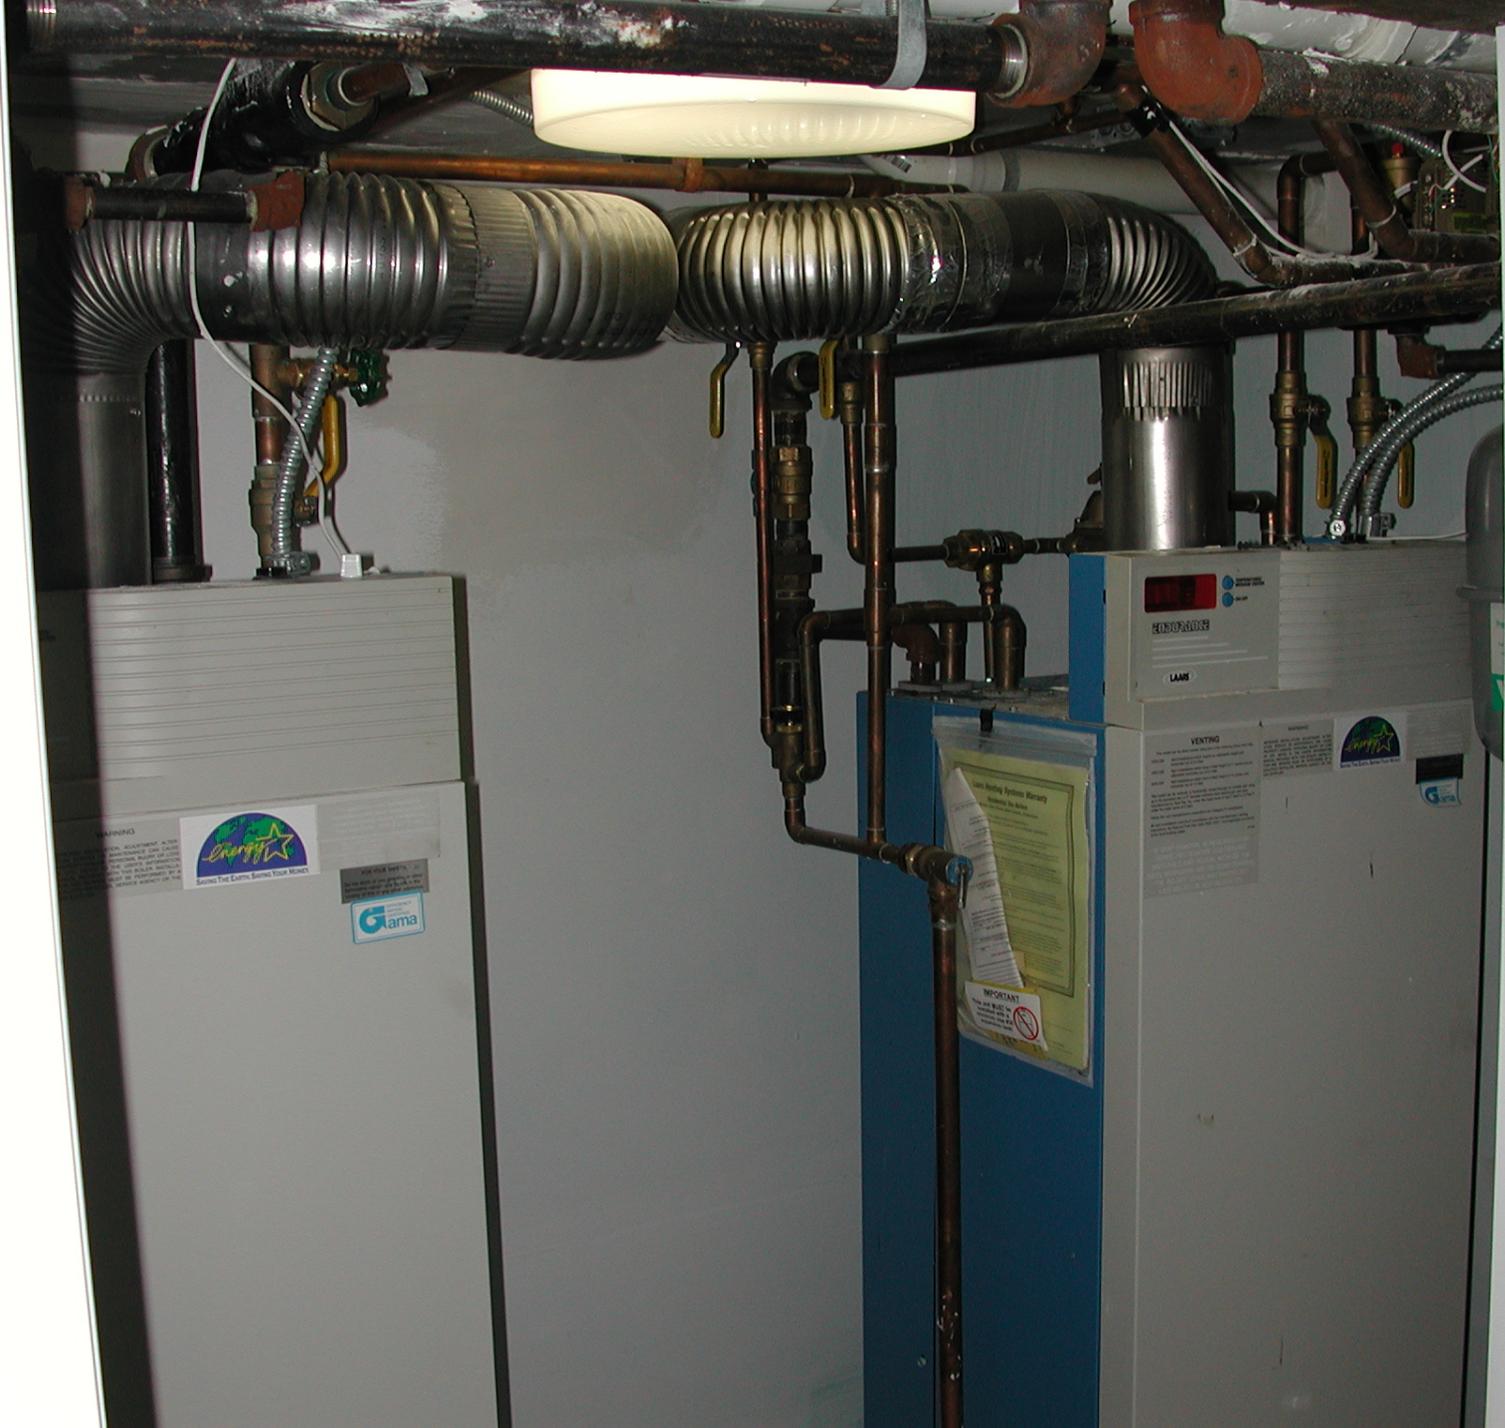
## ◆ Heating

- Sealed-combustion boiler
- Fin-tube radiators

## ◆ Ventilation

- High quality kitchen and bath fans
- No filtration and no dehumidification
- Gas Stove (at resident's request)

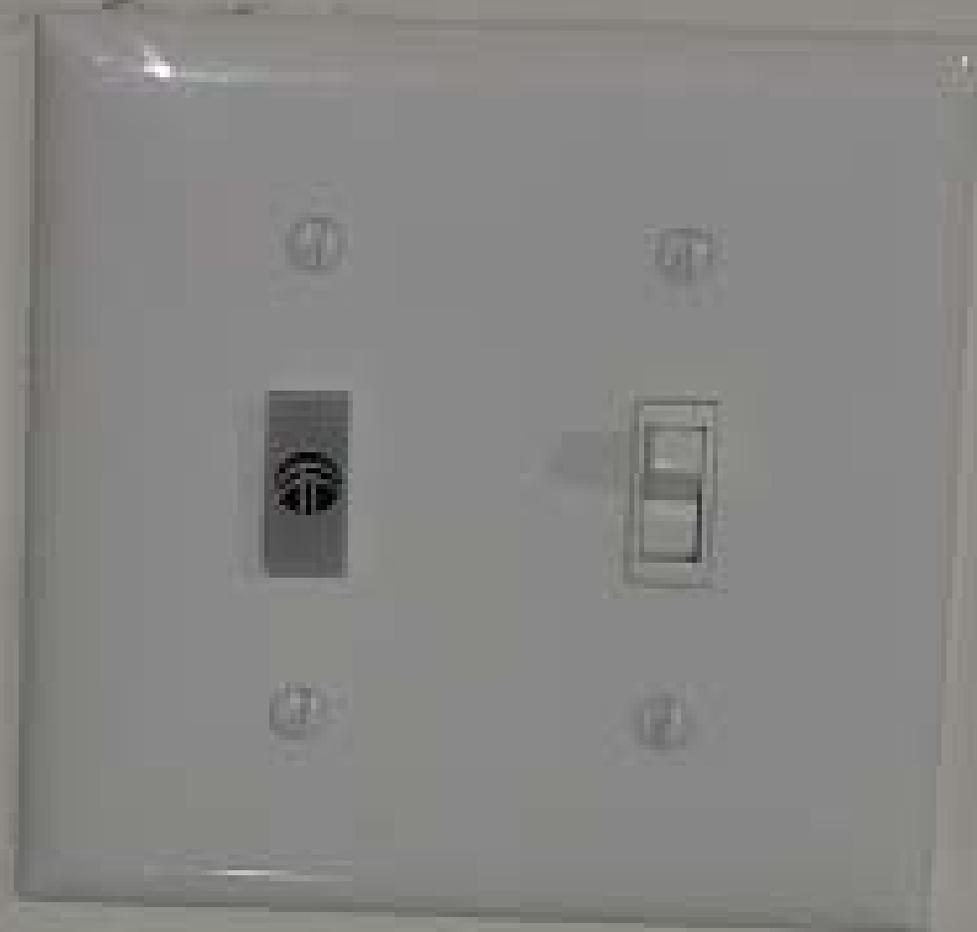
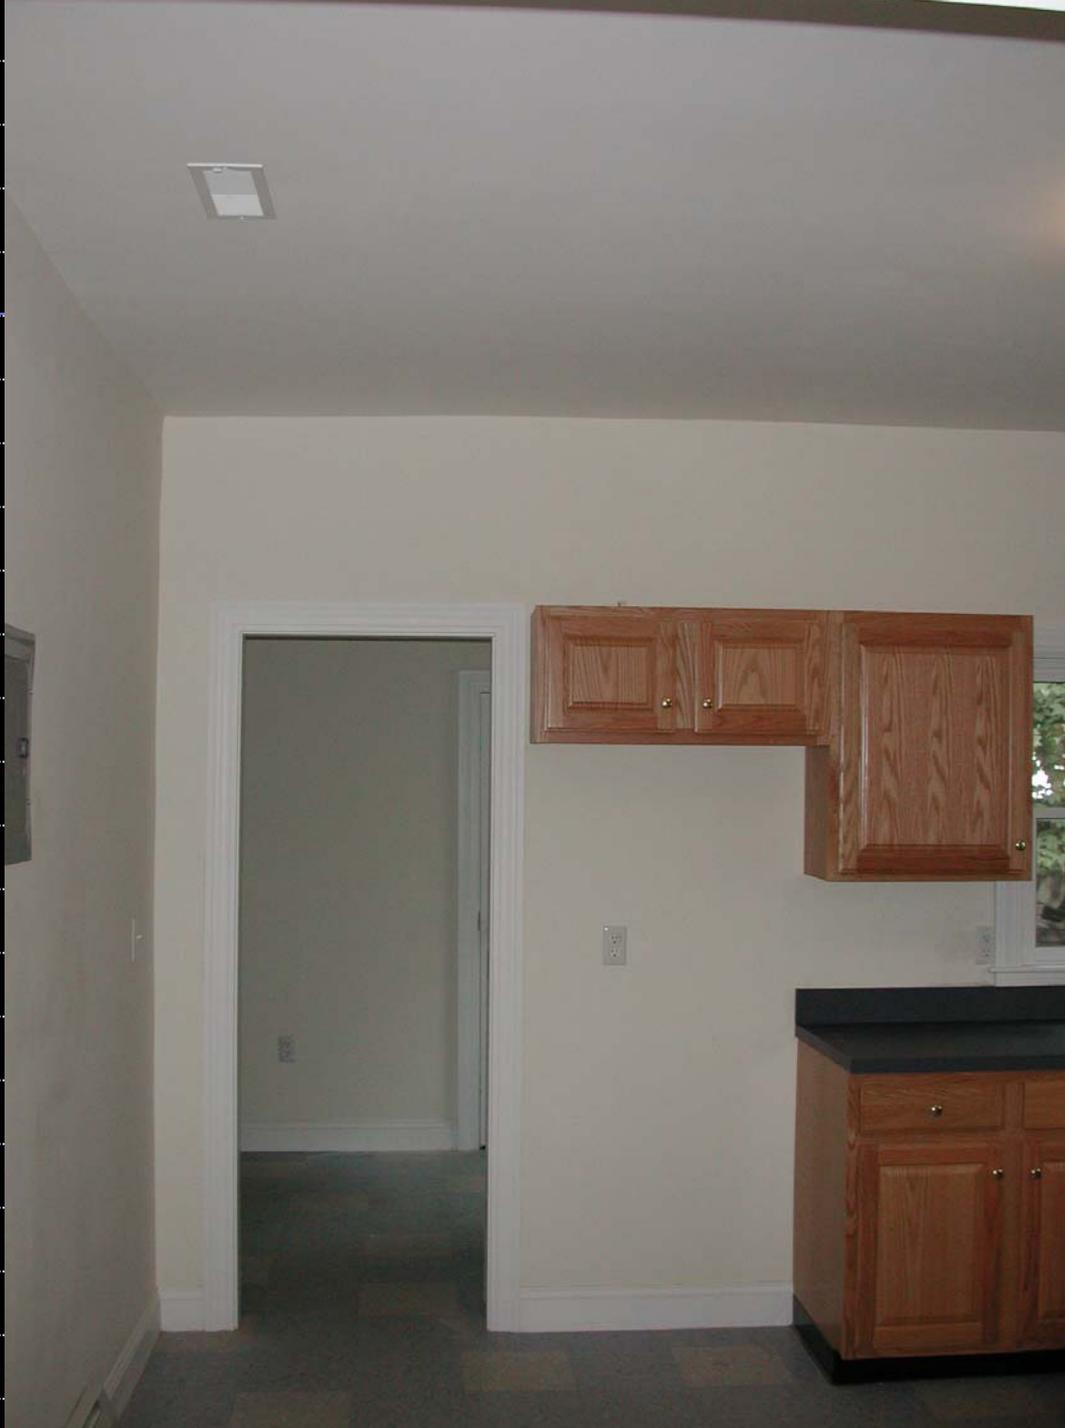
# Priority #3: Maintain Comfort and Provide Fresh Air

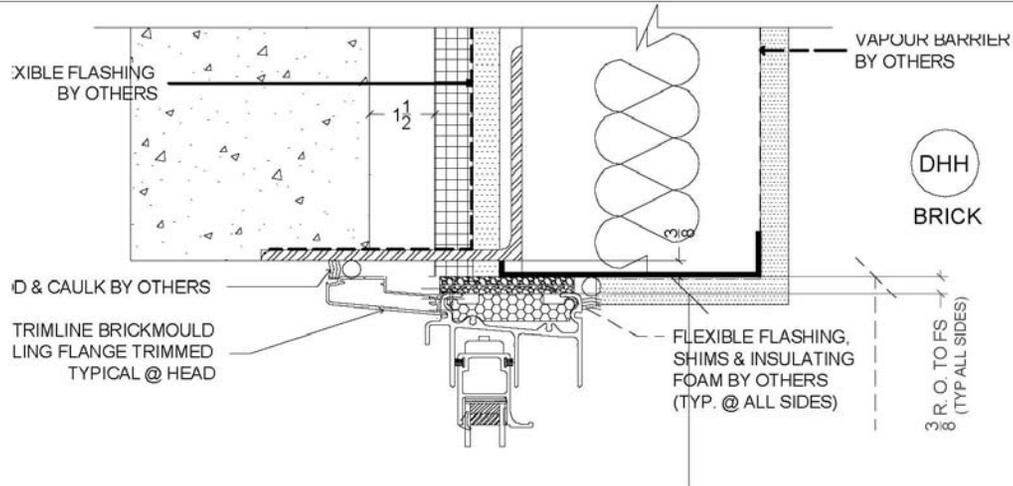
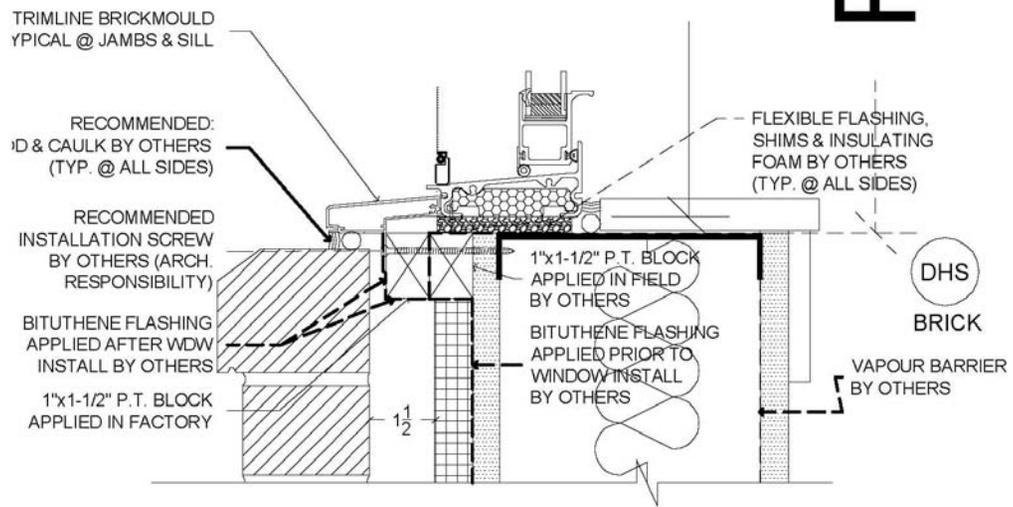
REF: NTG 16F TITLE: MAVERICK - PHASE 1: ONE MIDRISE BLDG MR-B-A902 REVISED WALL DETAILS

# Priority #1: Control Moisture

- ◆ **Windows** – Install Pan flashing
- ◆ **Underground Garage** – Install crushed stone, vapor barrier, and insulation
- ◆ **Vapor and Air Control** - Isolate apartments from corridors

**NOTE:**  
 1/2 SCREEN TYPICAL  
 FOR ALL WINDOWS.  
 PROVIDE SEPARATELY.

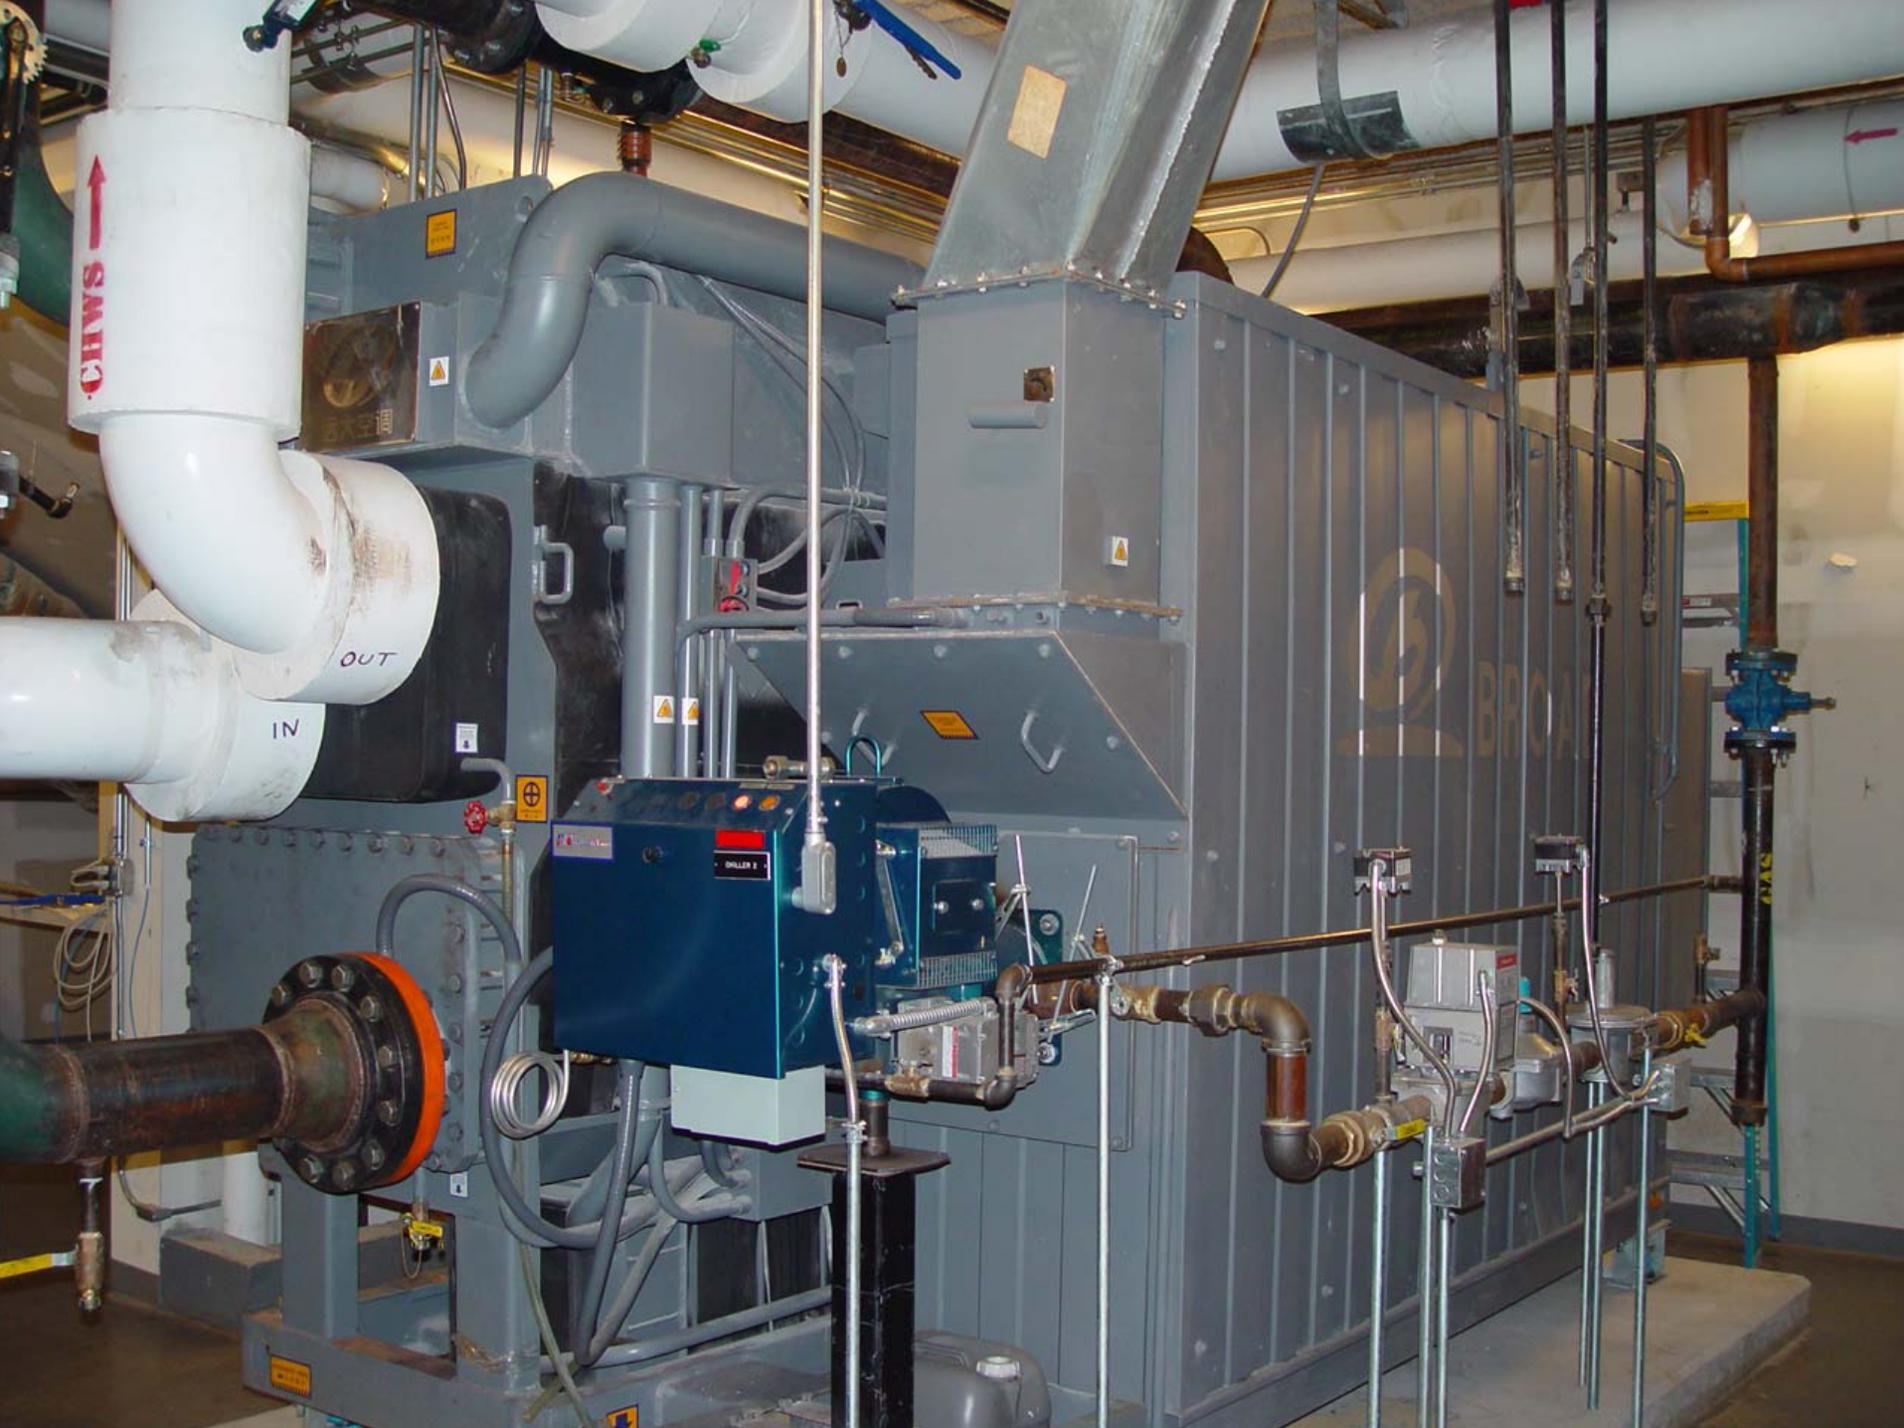
# Priority #3: Maintain Comfort and Provide Fresh Air

## ◆ Heating/ Cooling

- Gas absorption boiler/ chiller
- Whalen 2-pipe fan coils with free cooling

## ◆ Ventilation

- Central kitchen and bath exhaust
- Dedicated apartment supply air
- Isolate apartments from corridors
- Electric stoves

4 AIR INTAKE @ FAN COIL UNIT  
 3" = 1'-0"
